Naval Research Laboratory

NRL Memorandum Report 6404

## Electronic Space Fire Protection: Halon 1301 Cabinet Penetration Tests

January 26, 1989

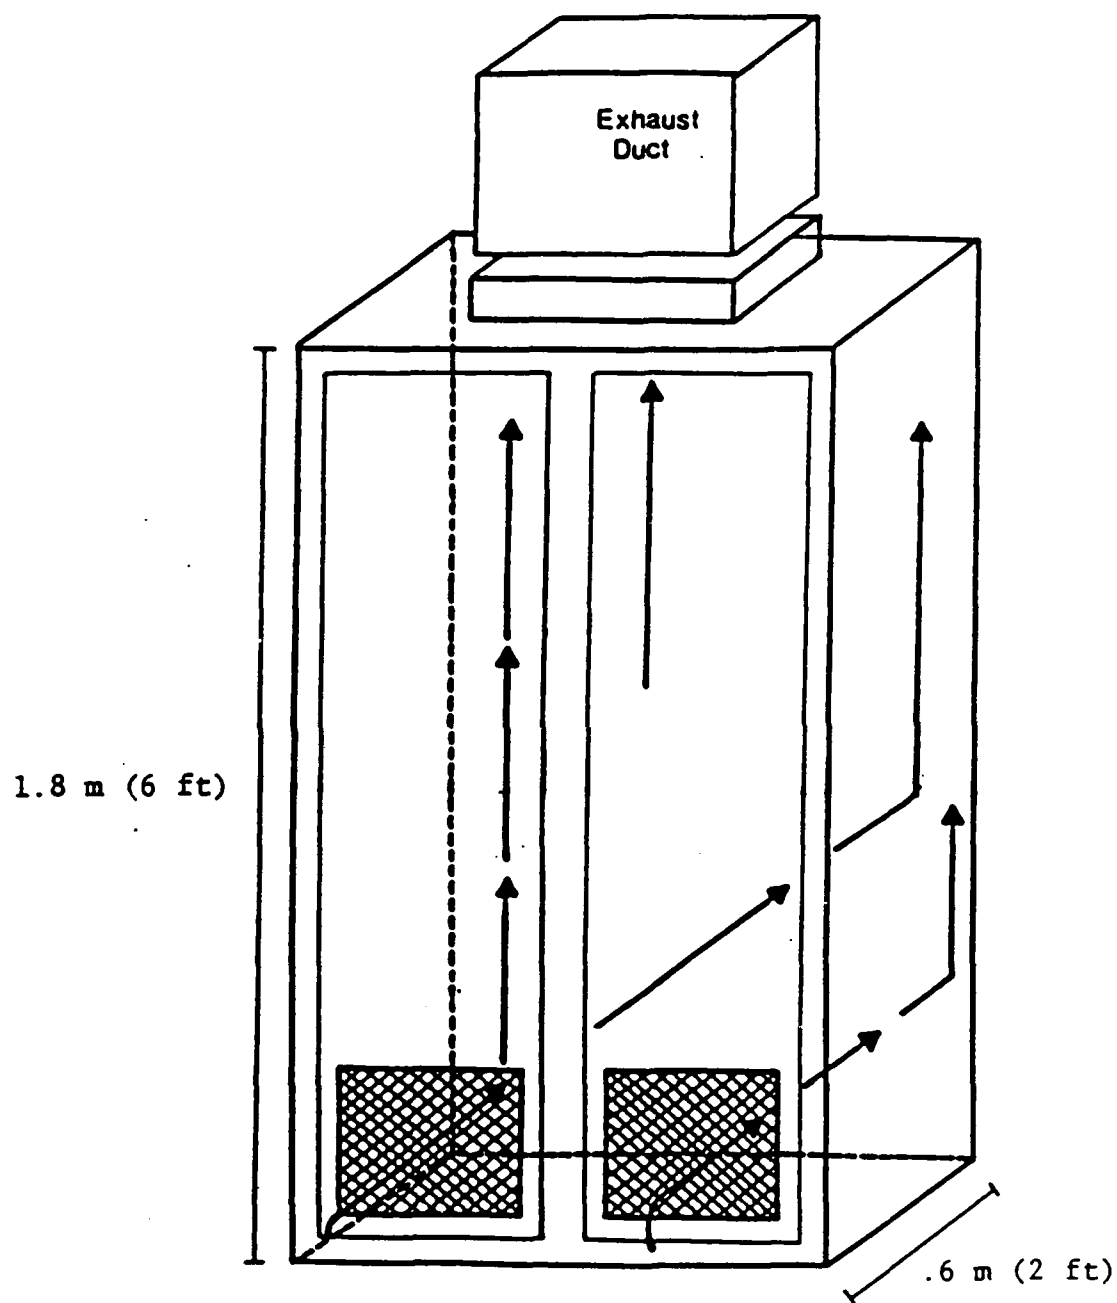
Fig. 1 - Typical shipboard electronics cabinet cooling scheme

Shipboard electronic cabinets that are water cooled usually do not have any openings in their exterior perimeter. These are generally consoles of the type found in Central Information Center (CIC) or Central Control Station [3]. Shipboard electronic cabinets that are air cooled, either fully or partially, obtain cooling in the same manner. This is done by interior cabinet cooling fans usually located at the cabinet top. These fans are configured to draw air conditioned room air through tightly filtered openings located near the cabinet base. The air is then circulated throughout the cabinet and discharged at the cabinet top. The used air discharges directly into an exhaust duct located above the cabinet, as shown in Fig. 1.

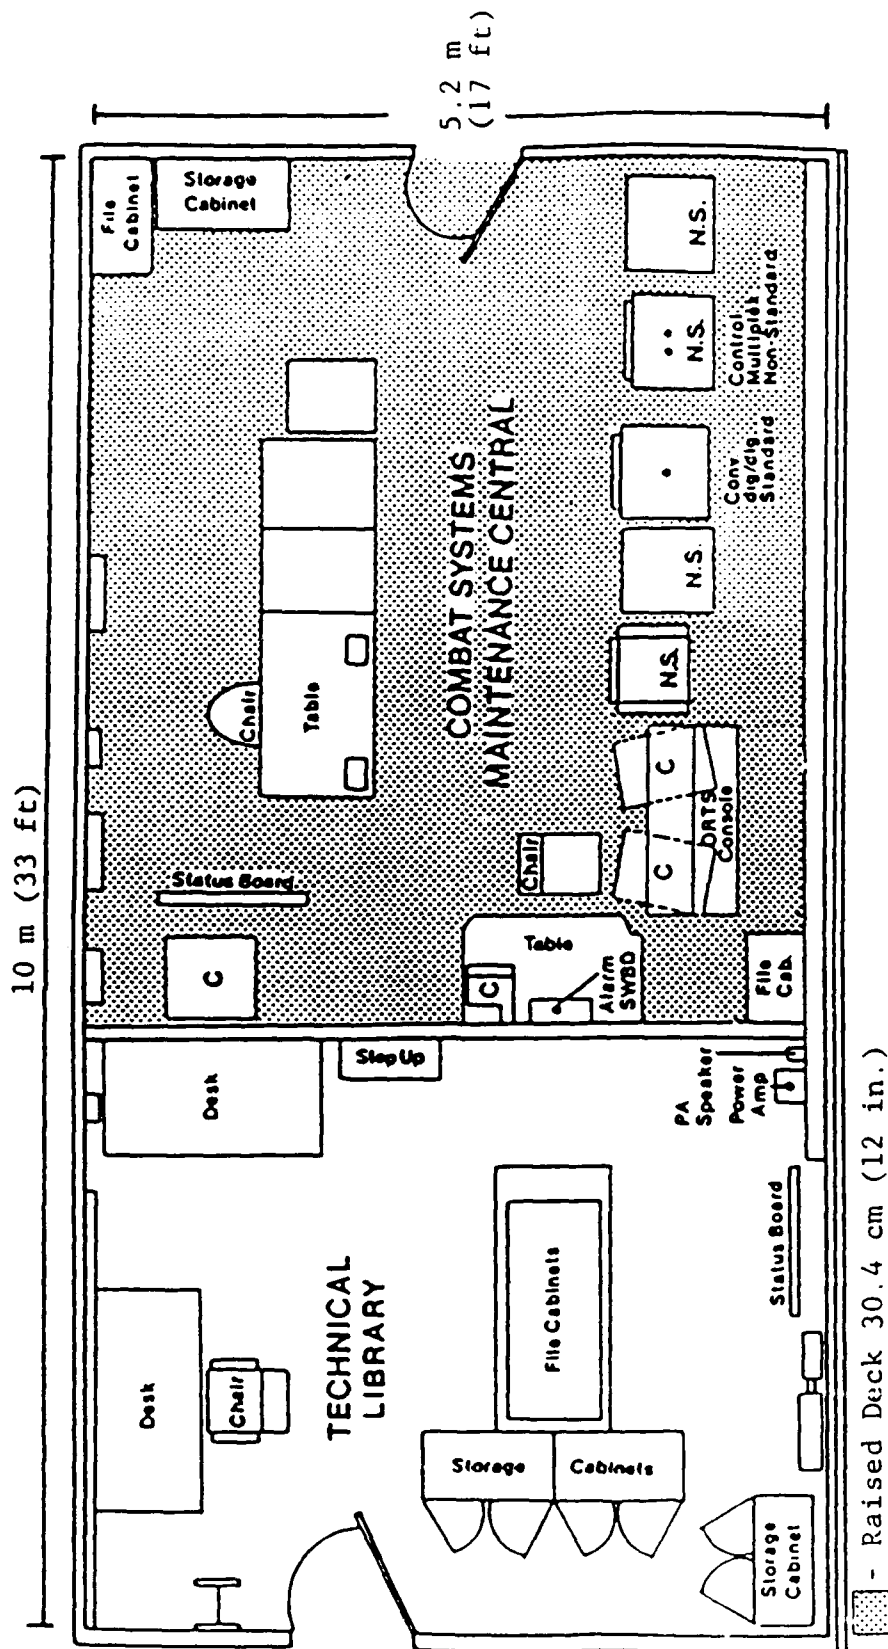
Fig. 2 - Plan view, Combat Systems Maintenance Central & Technical Library, Aegis Training Facility, Moorestown, NJ

The specific enclosure selected within the site was Combat Systems Maintenance Central, shown in Fig. 2. This space is approximately 10 m (33 ft) x 5.2 m (17 ft) with a 2.4 m (8 ft) ceiling. The total floodable enclosure volume is approximately 124.8 m<sup>3</sup> (4,500 ft<sup>3</sup>). Approximately half of the space contains a raised deck area that is 30.4 cm (12 in.) above the actual floor. This space contained a large cross section of electronic equipment and associated signal and power cables.

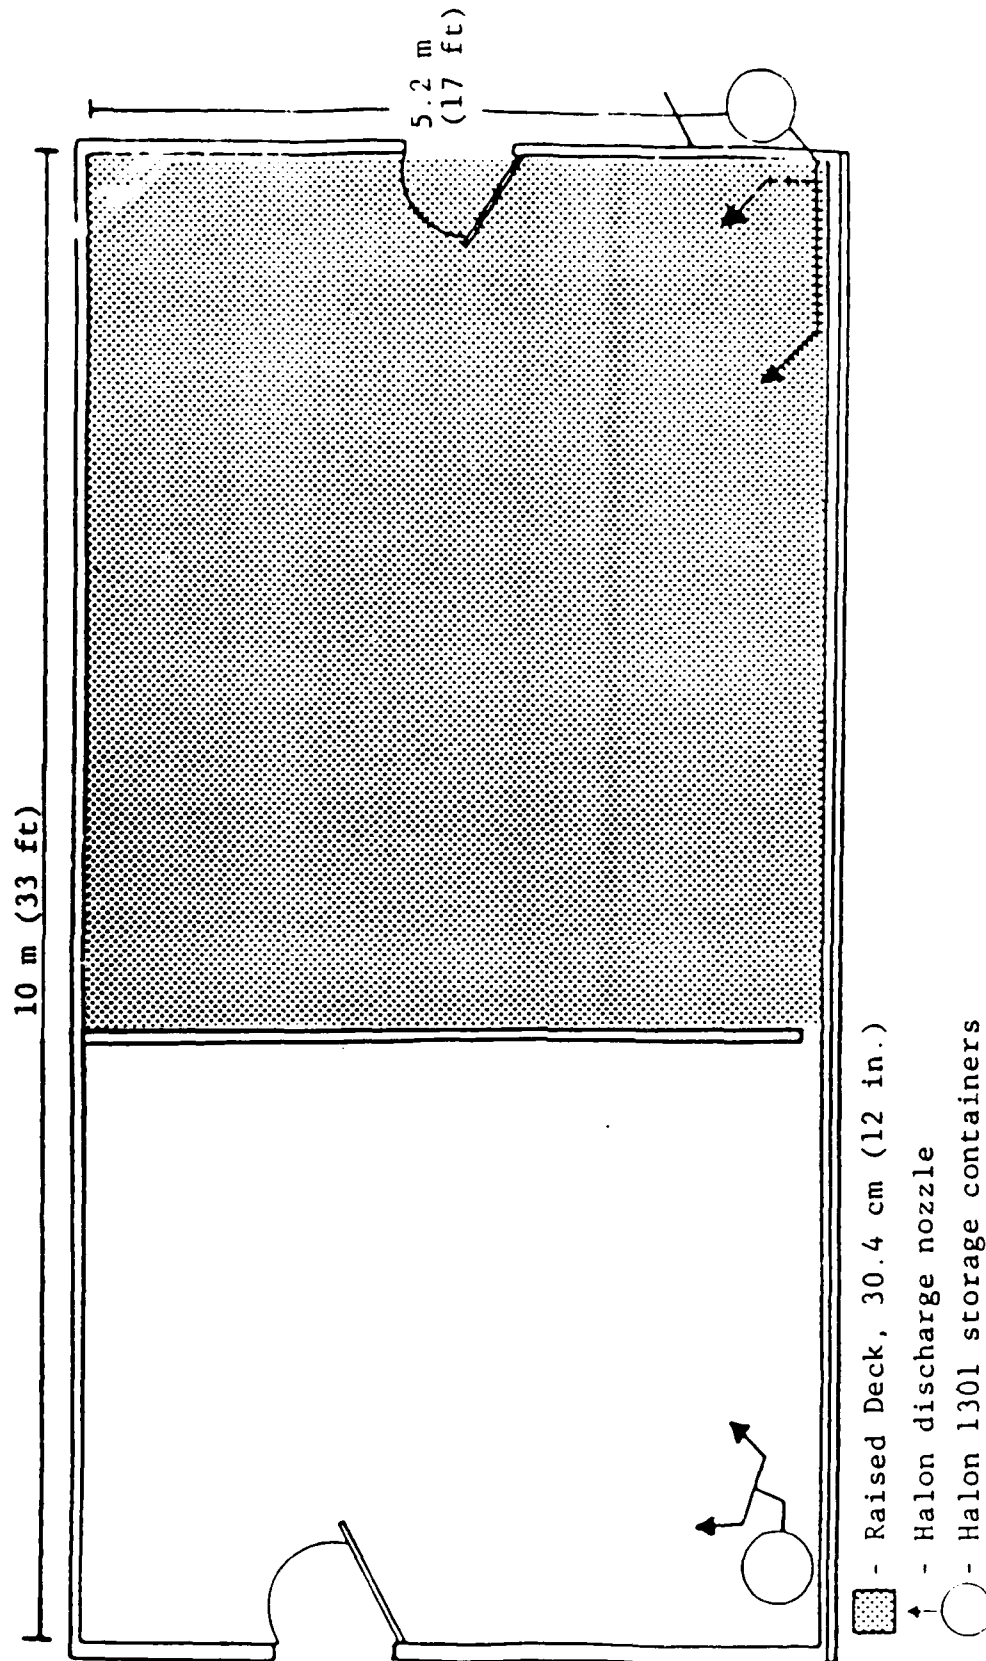
Fig. 3 - Halon 1301 total flooding system, Combat Systems Maintenance  
Central & Technical Library, Aegis Training Facility, Moorestown, NJ

Currently this space is protected with a modular Halon 1301 total flooding system designed for a single discharge, shown in Fig. 3. The system is made up of two Halon storage/discharge spheres. One sphere is located in the space itself, while the other is mounted on an outside wall. This system was designed to provide a 6% concentration, with the outside and the inside spheres containing 40.9 kg (90 lbs) and 22.7 kg (50 lbs), respectively [4]. The system is comprised of four discharge nozzles. Three nozzles discharge directly into the space, while one nozzle discharges under the raised deck area. The space is also served by a conventional HVAC system, with dampers interlocked with the Halon system.

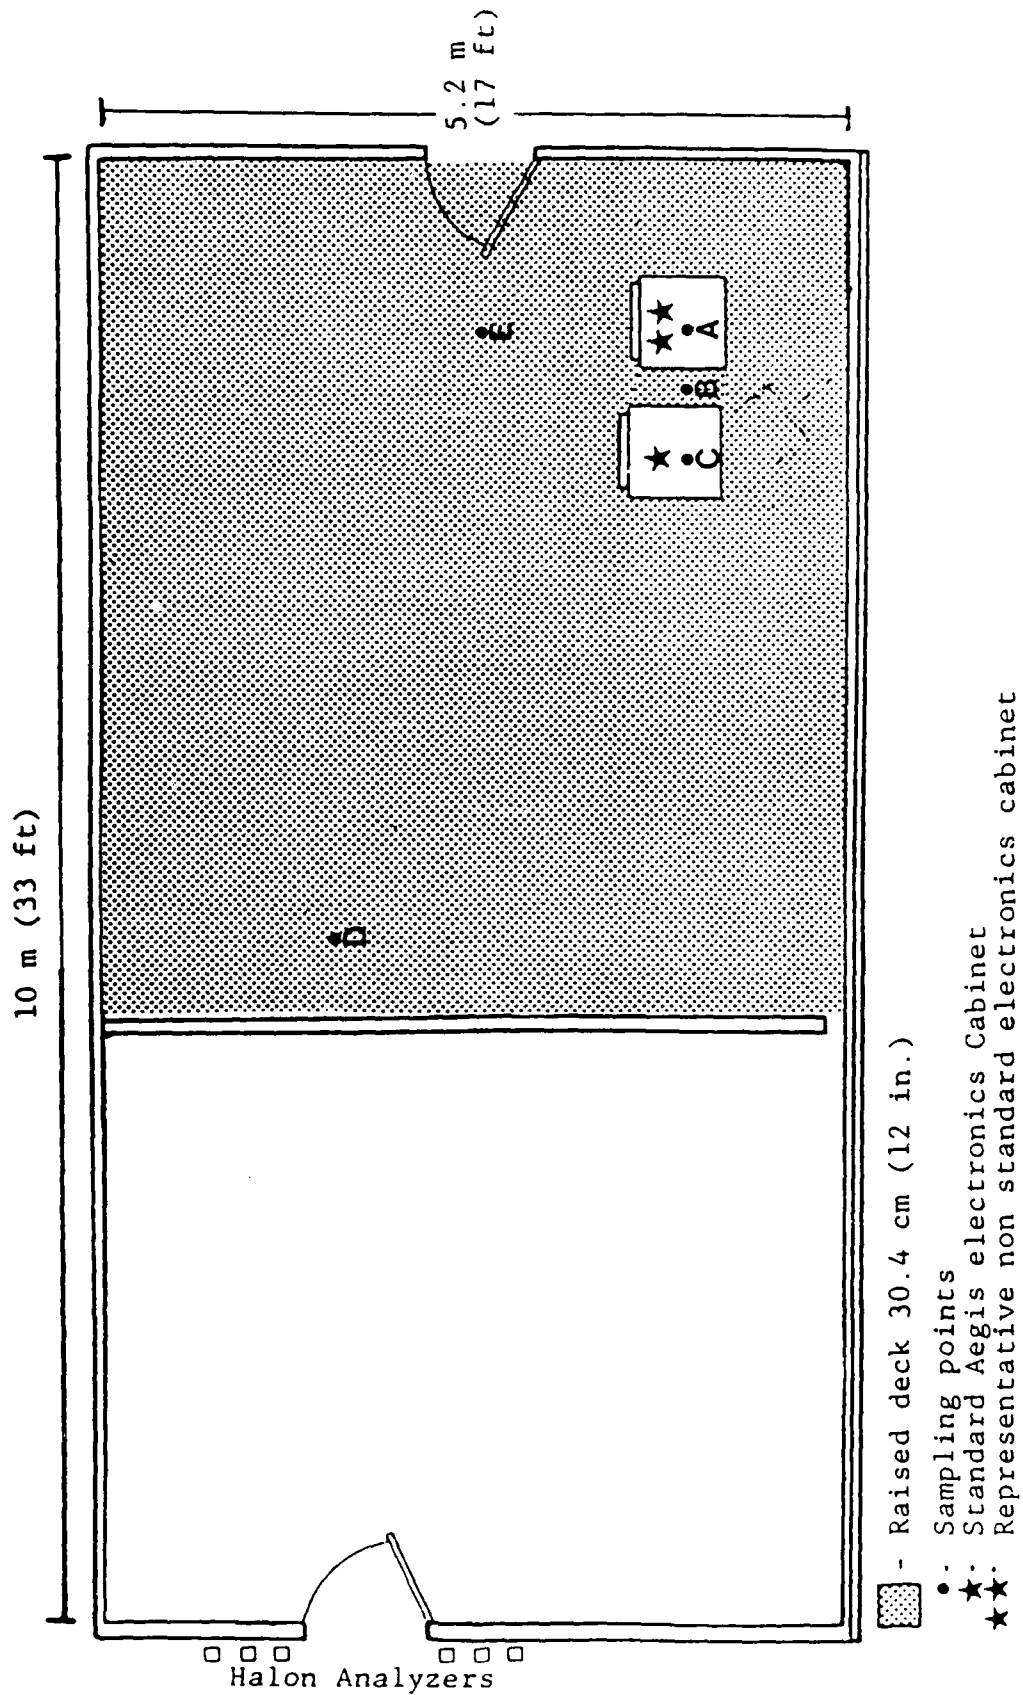
Fig. 4 - Halon 1301 instrumentation arrangement, Combat Systems Maintenance Central & Technical Library, Aegis Training Facility, Moorestown, NJ

A total of six thermal conductivity Halon 1301 analyzers were used. Each analyzer could accommodate three sampling points, thus providing a total of 18 sampling points. The six analyzers were located remote to the space as shown in Fig. 4. Transit from the actual sampling points to the analyzers was accomplished by .64 cm (.25 in.) Tygon tubing.

A top view of all the specific sampling points is also shown in Fig. 4. The vertical sampling trees are shown as A, B, C, and D. Position E is a stand alone sampling probe located under the raised deck area. Figure 5 is a side view showing vertical sampling trees A, B, and C. Also shown are the two electronic cabinets selected for Halon penetration tests. These cabinets were:

Figures 15 and 16 show data from sampling points K1, K13, and K20. These sampling points were all located beneath the raised deck area, as shown in Figs. 4, 5 and 6. Sampling point K1 is located inside a large cable bundle, while K13 and K20 are positioned in open air 15.2 cm (6 in.) above the actual floor. Review of Figs. 15 and 16 reveal immediate Halon 1301 penetration into the instrumented cable bundle. All under floor concentrations were well in excess of the 6% design concentration. The reduction shown in Fig. 15 of probe K20 occurred when sampling point K1 and K0 were interchanged. This was done by the operators of the Halon analyzers to confirm the low local concentration recorded at point K0. As discussed previously, this was caused by the inadvertent operation of a recirculation duct.

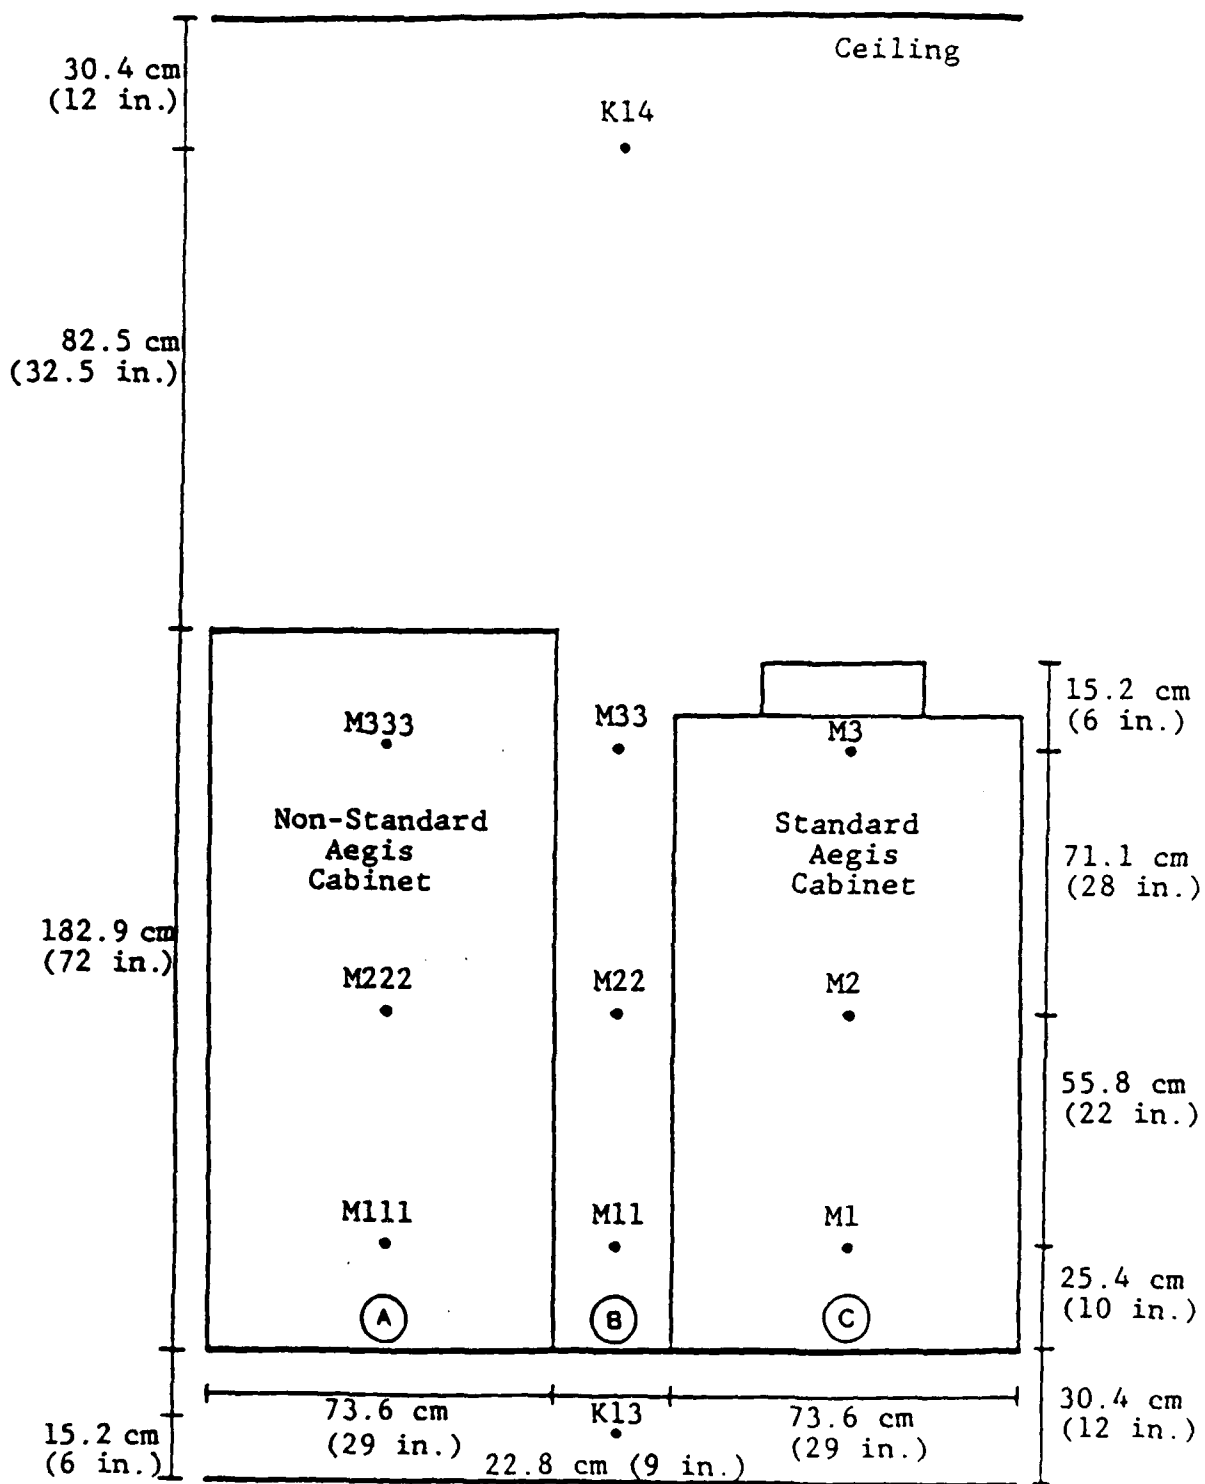
Fig. 5 - Halon 1301 vertical sampling trees A, B, and C

Both of these cabinets are about the same size, 1.8 m (6 ft) x .61 m (2 ft) x .74 m (2.5 ft) and were located adjacent to each other. This arrangement was quite convenient because it allowed direct comparisons of Halon 1301 penetration between a Standard Aegis electronics cabinet and a non-standard electronics cabinet. Probes shown in Fig. 5, numbered M11, M22, and M33, represent external cabinet probes located in the space between the cabinets. These probes were positioned at locations adjacent to internal cabinet probes. This provided a direct comparison of the internal and external Halon 1301 concentration profiles. In addition, probe 13 was placed beneath the raised deck directly below the two instrumented cabinets.

Halon concentrations were also monitored in three areas under the raised deck. One probe K20 formed the bottom-most probe of vertical sampling tree D. This probe was located in the open, 15.2 cm (6 in.) off the actual floor. Another probe, K1, was placed in a large cable bundle under the raised deck, shown as position E in Fig. 4. The final probe, K13, was placed under the raised deck directly below the instrumented cabinets as shown in Fig. 5.

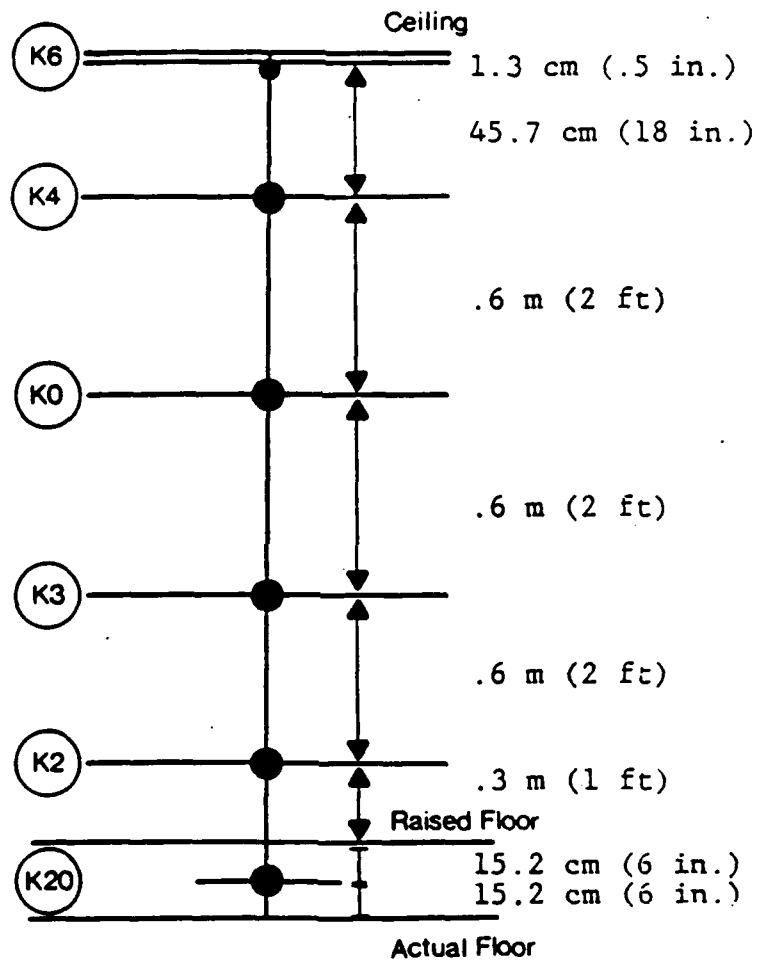
# SAMPLING TREE D

Fig. 6 - Side view of vertical sampling tree from floor to ceiling

The concentration profile was also monitored at the vertical sampling tree D. Vertical sampling tree D can be seen in Figs. 4 and 6. This vertical sampling tree extended from the floor to the ceiling, starting with a probe located 1.37 cm (1/2 in.) below the ceiling. Others were located in .6 m (2 ft) increments progressing towards the floor. The sampling probes were held in this position by attaching them with tape to an existing structural support column.

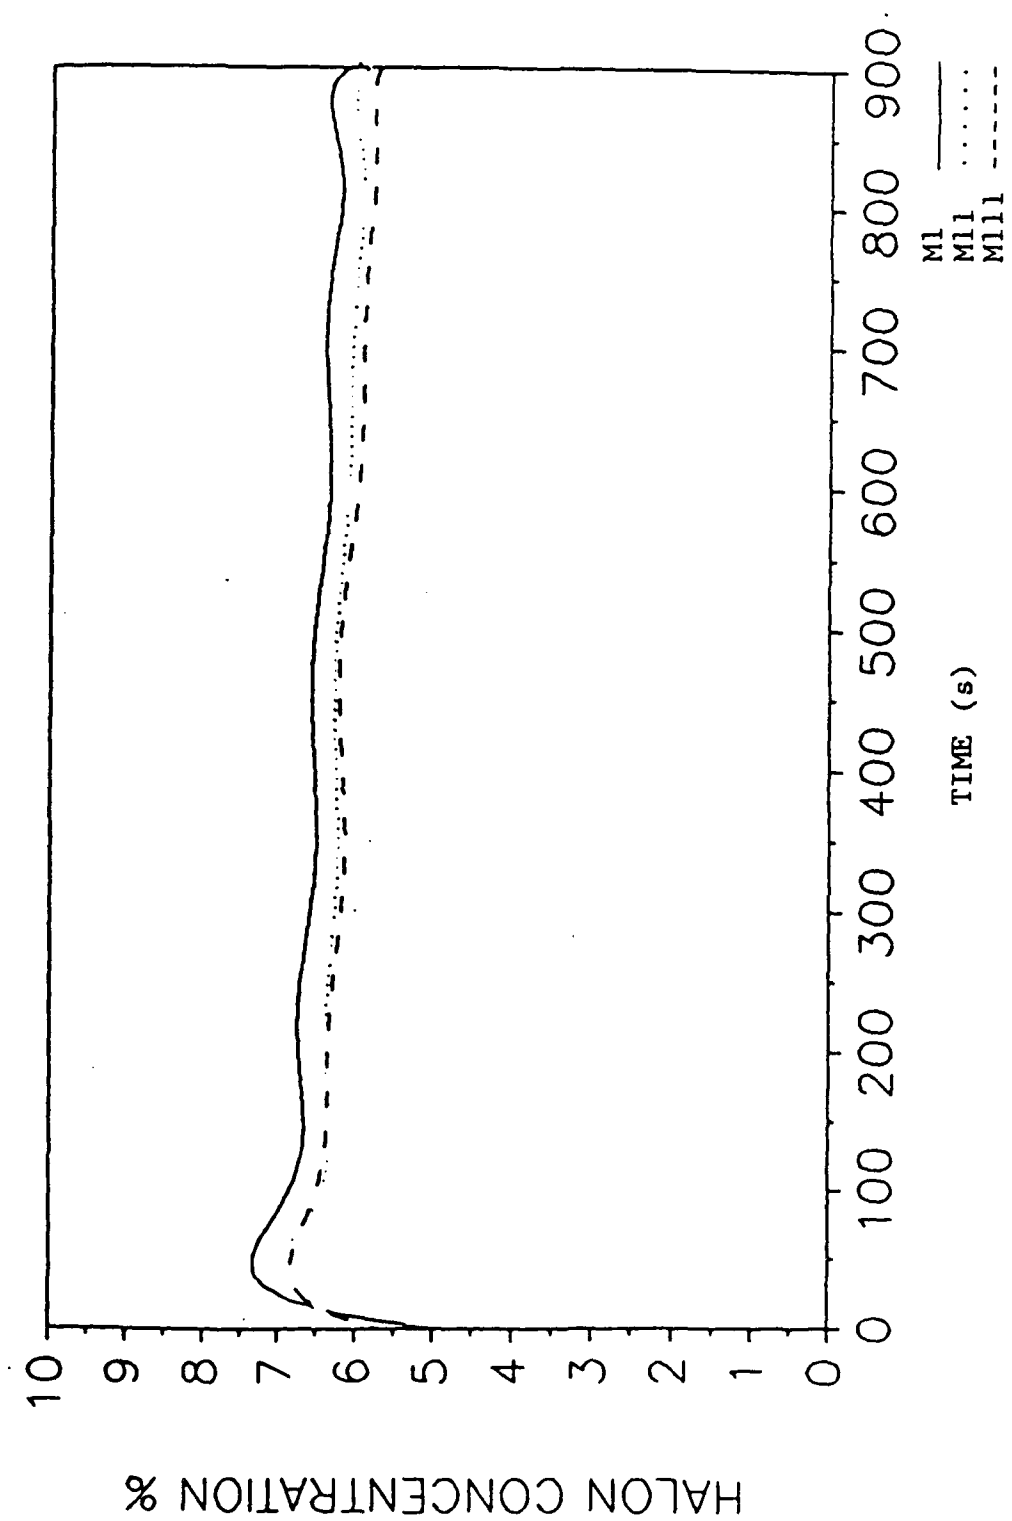
Fig. 7 - Test 1, Halon concentrations at vertical sampling trees  
A,B,C, 25.4 cm (10 in.) above raised deck, fans off

Figures 7 through 12 represent the plotted data obtained from various vertical sampling positions A, B, and C. These figures present comparisons of the time based Halon 1301 concentrations produced inside the instrumented cabinets with those recorded at the same external positions. Figures 7, 8, and 9 show data that was obtained during Test #1 (internal cabinet cooling fans off), while Figs. 10, 11 and 12 represent data obtained during Test #2 (internal cabinet cooling fans on). Careful review of these figures reveals several predominate trends, namely:

1. The data show that Halon 1301 rapidly entered the two instrumented electronic cabinets, regardless of the operation of the internal cooling fans. During both tests the design concentration of 6% Halon 1301 was obtained inside of the cabinets in less than 10 s following system discharge.

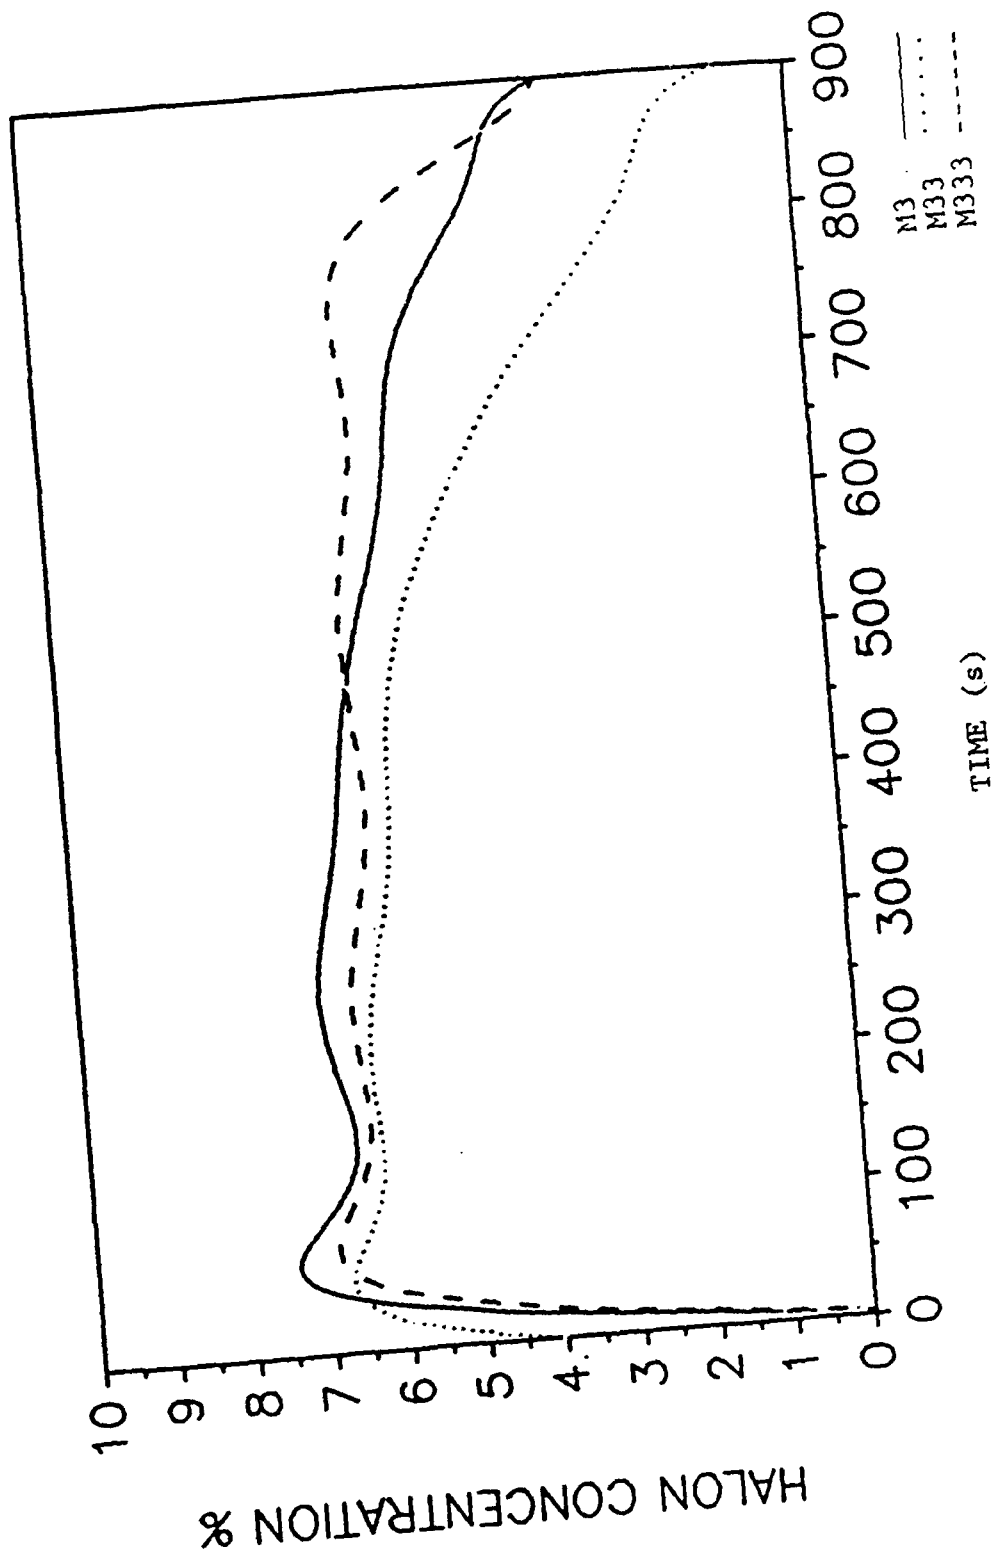
Fig. 9 - Test 1, Halon concentrations at vertical sampling trees A,B,C, 152.4 cm (60 in.) above raised deck, fans off

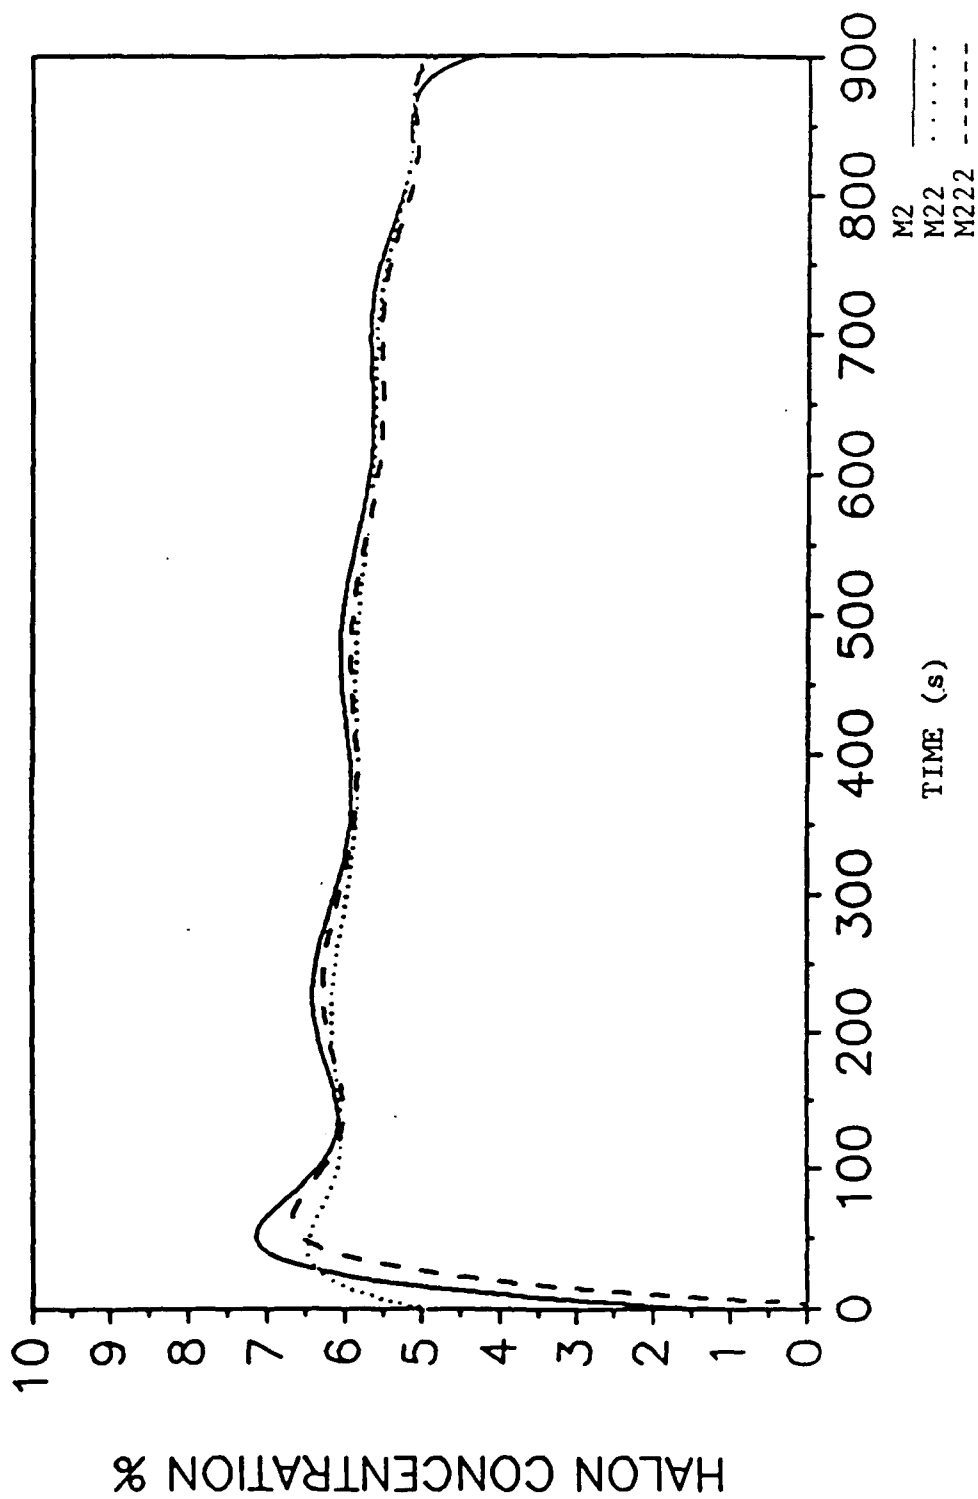
Fig. 11 - Test 2, Halon concentrations at vertical sampling trees A,B,C, 81.3 cm (32 in.) above raised deck, fans on

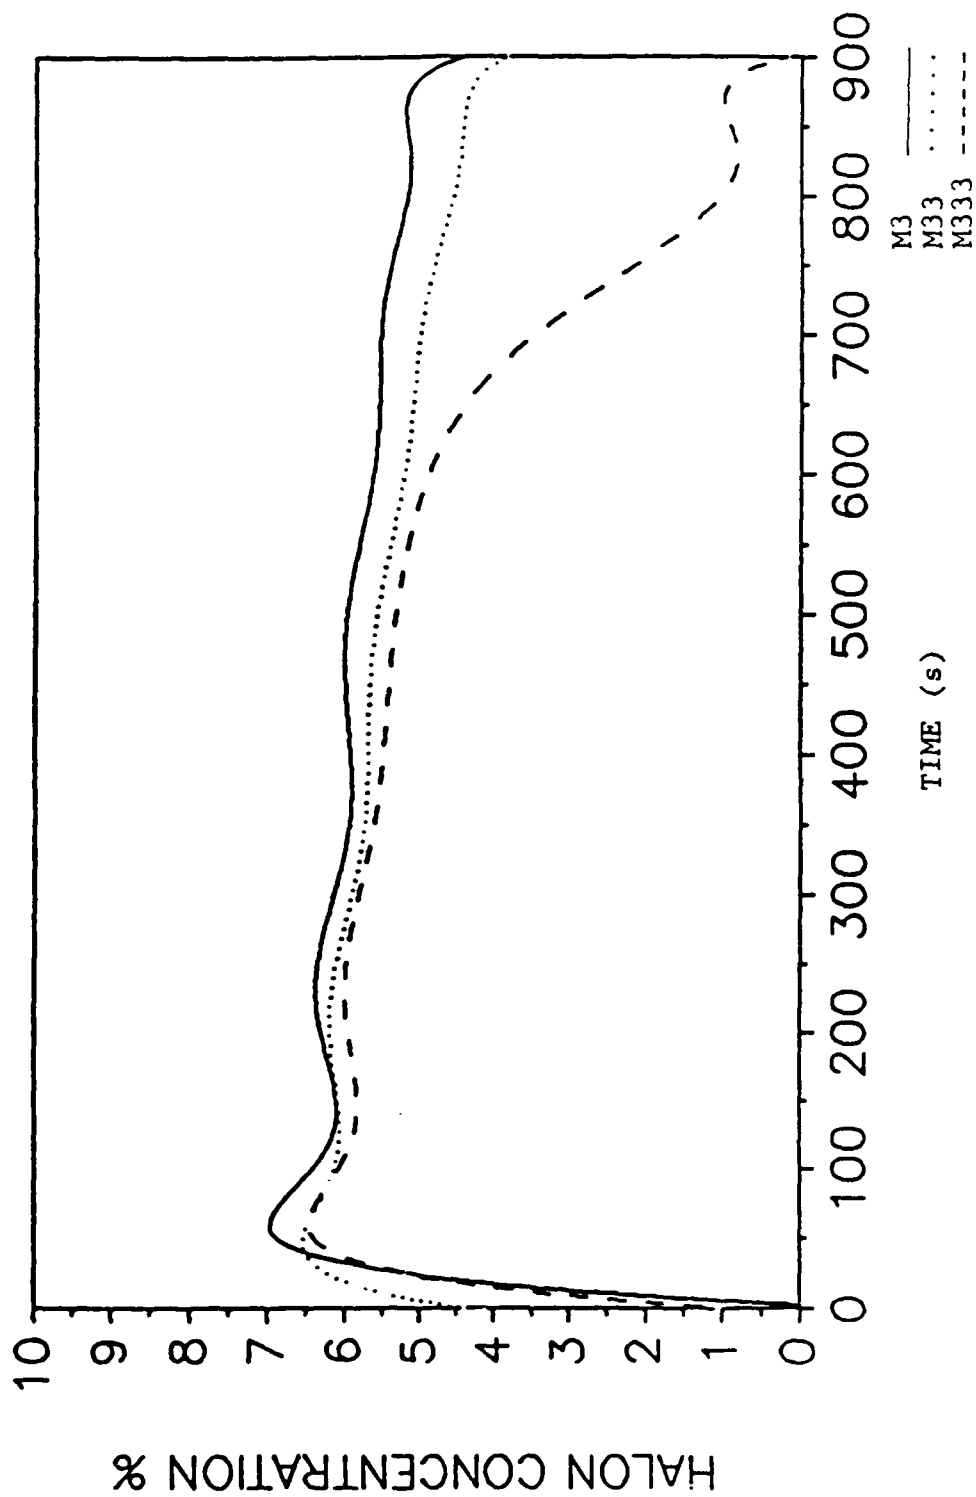
Fig. 12 - Test 2, Halon concentrations at vertical sampling trees A,B,C, 152.4 cm (60 in.) above raised deck, fans on

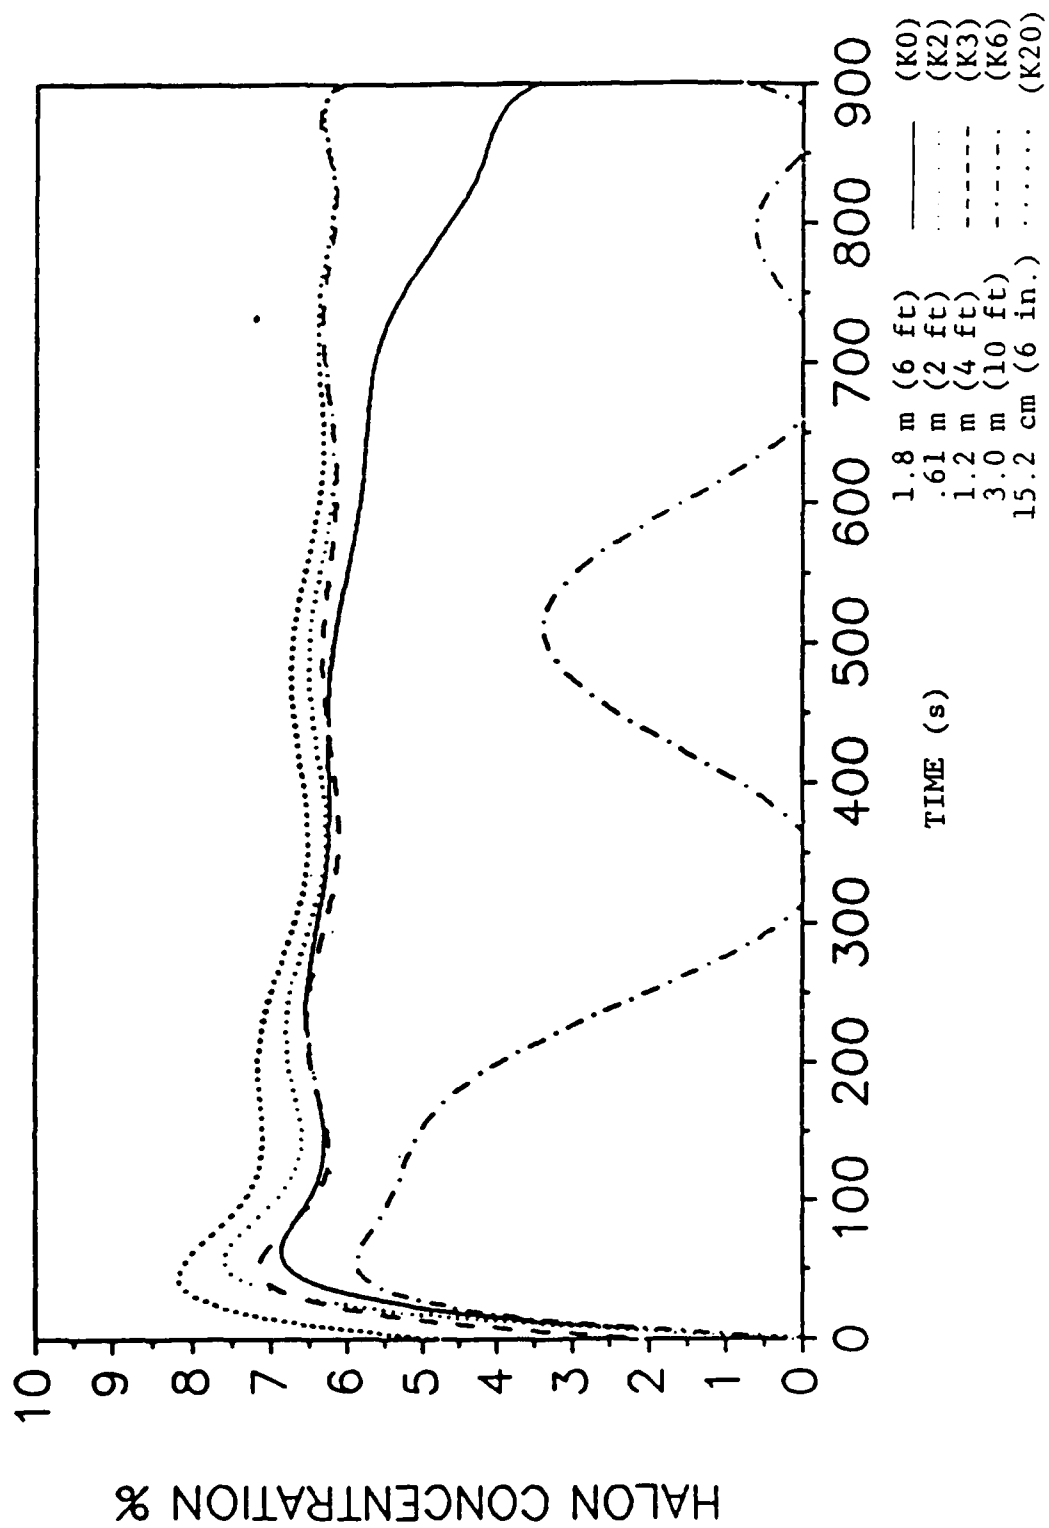
Fig. 13 - Test 1, Halon concentrations at vertical sampling tree D, fans off

2. These data also show a gradual reduction in the Halon 1301 concentration profile beginning at the highest point. Verification of this can also be seen in Figs. 13 and 14, which represent data obtained in Test #1 and Test #2, respectively. Each figure shows the vertical concentration profile of Halon 1301 recorded at various levels above the actual floor. The sampling levels were approximately 3.0 m (10 ft), 1.8 m (6 ft), 1.2 m (4 ft), .61 m (2 ft), and 15.2 cm (6 in.). These vertical levels correspond to sampling points shown on Fig. 6 as K6, K0, K3, K2, and K20, respectively. Evaluation of Figs. 13 and 14 show a distinct time based reduction in the Halon 1301 concentration starting at the ceiling and progressing towards the floor. This descending interface is typical of Halon 1301 leakage from compartments. The time at which the Halon 1301 concentration profile descends is controlled predominately by breaches in

the enclosure's air tightness. Hand held Halon 1301 analyzers were used outside the compartment to check for leaking areas during each test. Minor leaks were detected near the floor during each test.

In addition, during Test #1 it was noted that sampling point K0, which is located approximately 1.8 m (6 ft) above the actual floor, showed a consistently low localized Halon 1301 concentration. A post-test investigation showed that a closed loop recirculation system had inadvertently been left in operation during Test #1. This could explain the low Halon 1301 concentrations recorded by sampling point K0. The recirculation duct was approximately 1.5 m (5 ft) away from this sampling point and discharged air directly towards it. This could also explain the slightly higher and prolonged Halon 1301 concentrations recorded during Test #1. The operating recirculation system served as an excellent mixer for the Halon 1301/air mixture. Prior to conducting Test #2 this duct was sealed and other recirculation fans secured.

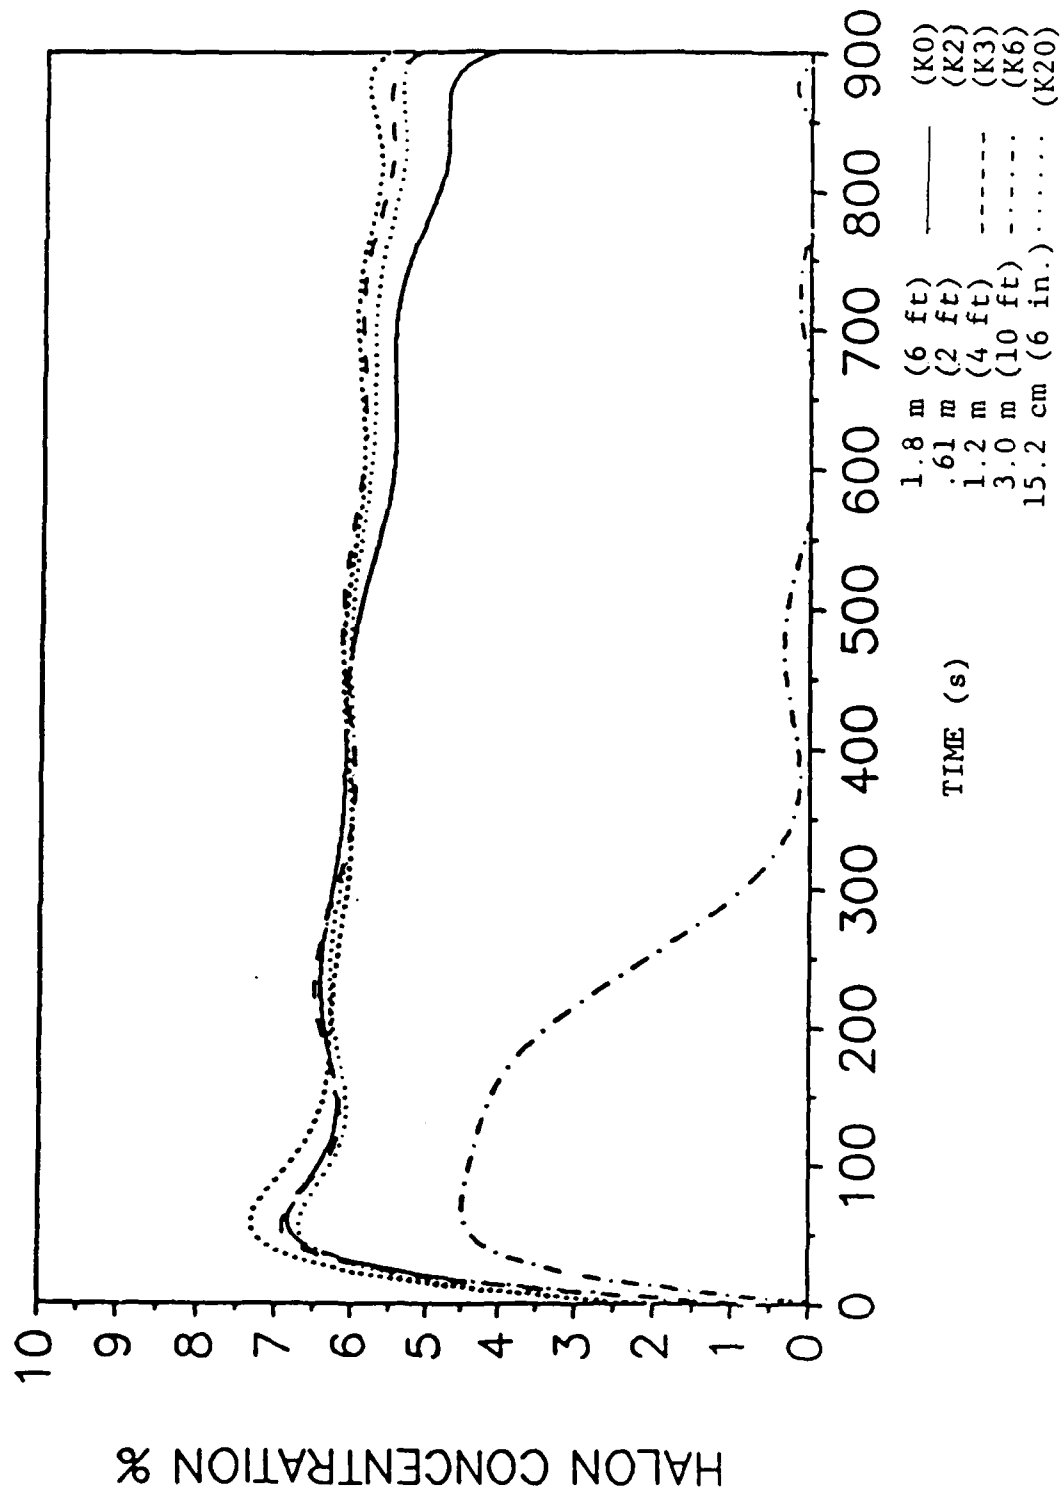
Fig. 14 - Test 2, Halon concentrations at vertical sampling tree D, fans on

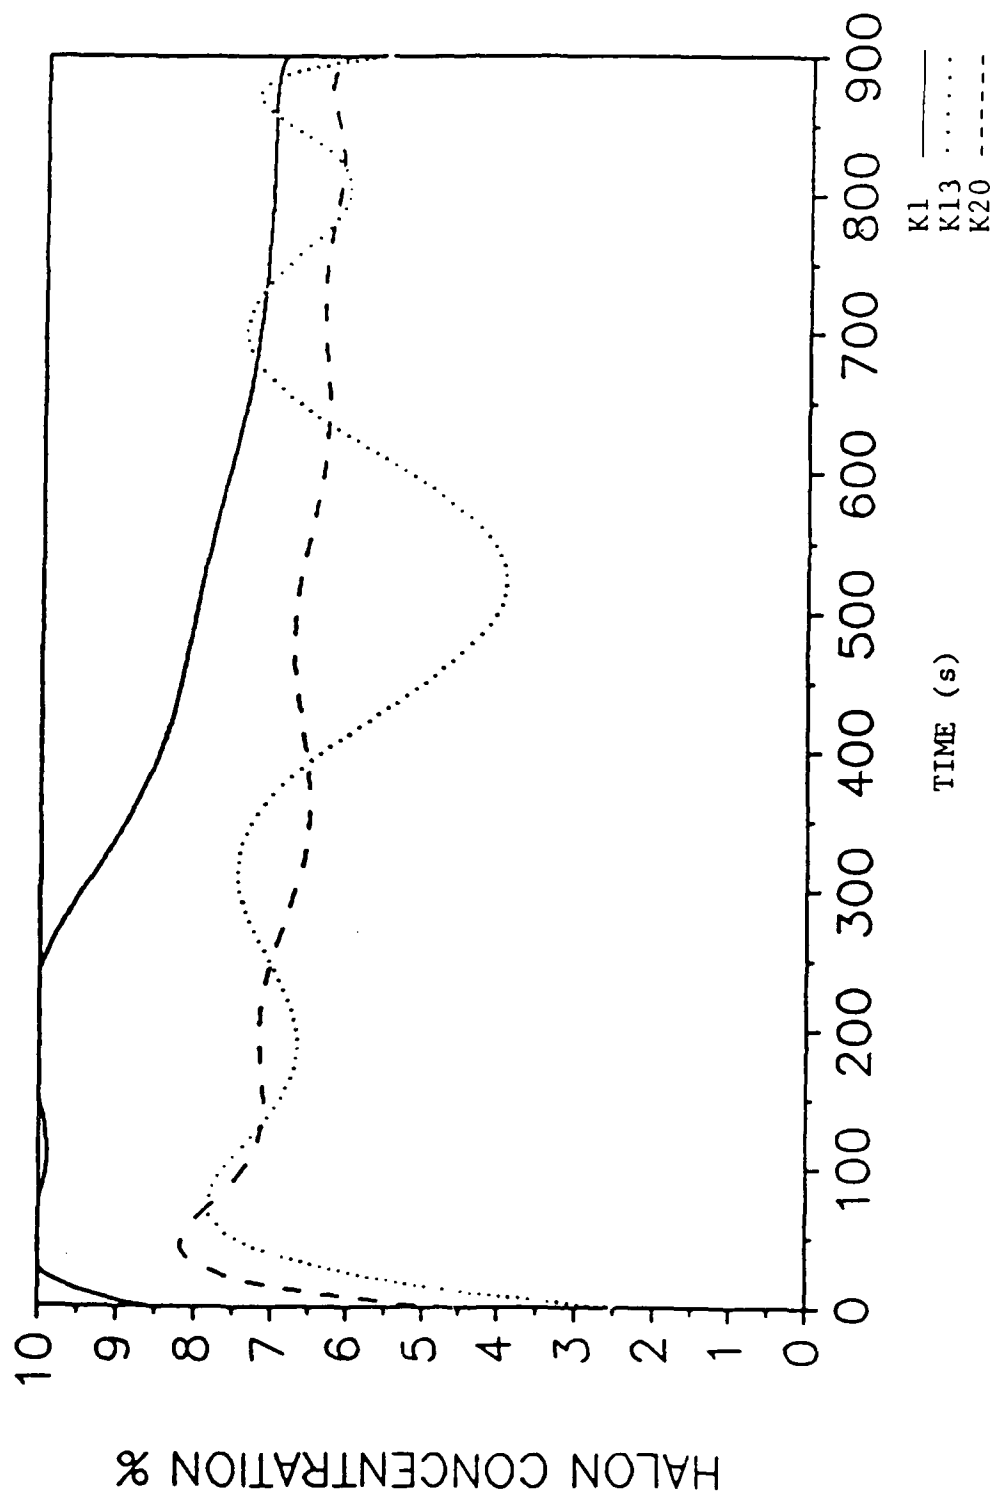
Fig. 15 - Test 1, Halon concentrations beneath raised deck, fans off
